# Inspection Report

## Sample Report

1234 Every Street  
St. Louis MO 63122

<b>Date:</b> 5/1/2009	<b>Time:</b> 11:00 AM	<b>Report ID:</b> 00000
<b>Property:</b> 1234 Every Street St. Louis MO 63122	<b>Customer:</b> Sample Report	<b>Real Estate Professional:</b>

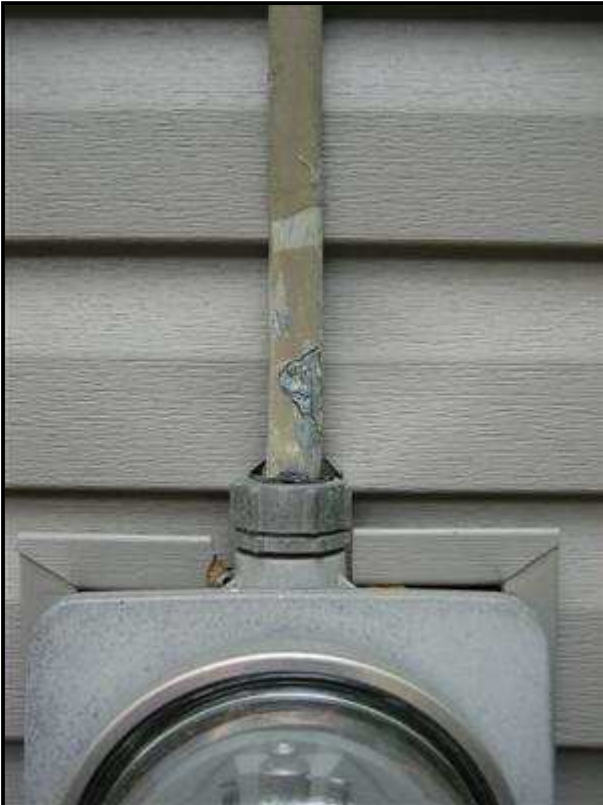
3.0 Picture 1 Damaged SE Cable

The entrance cable connecting the power source to the meter has damaged covering. This condition requires a new cable. Contact an electrical contractor for replacement as necessary.

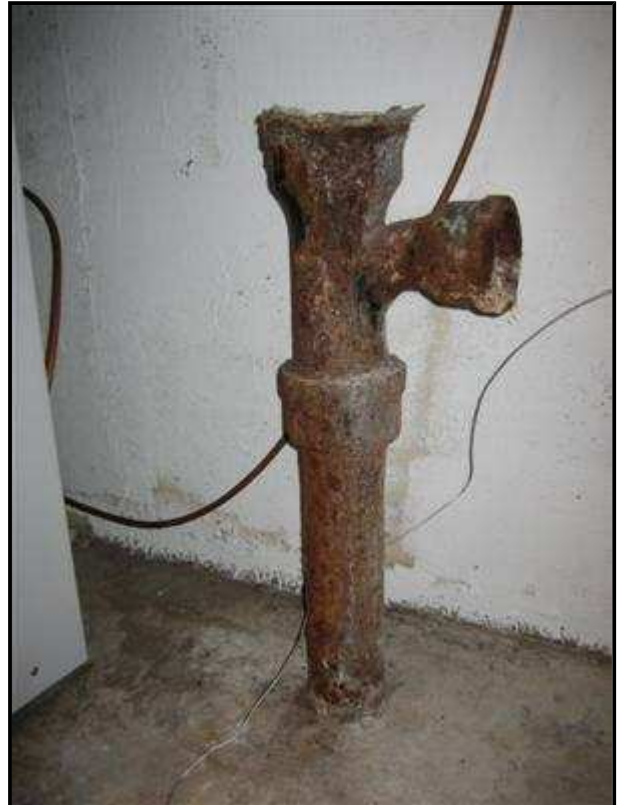
3.0 Picture 2 Corroded Standpipe

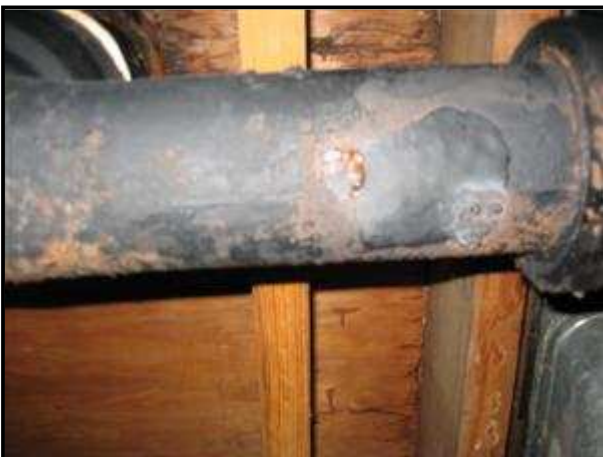
3.0 Picture 3 Main Stack Closet Bend

The waste piping is the original cast iron and the main floor drain is located in the basement utility area. Have a plumber replace stacks and closet bends as needed.

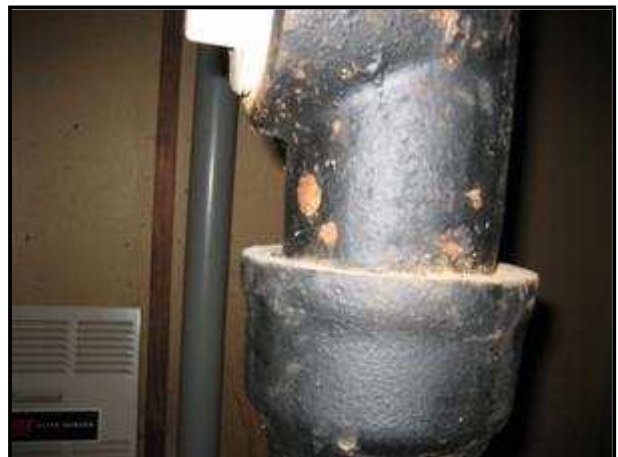
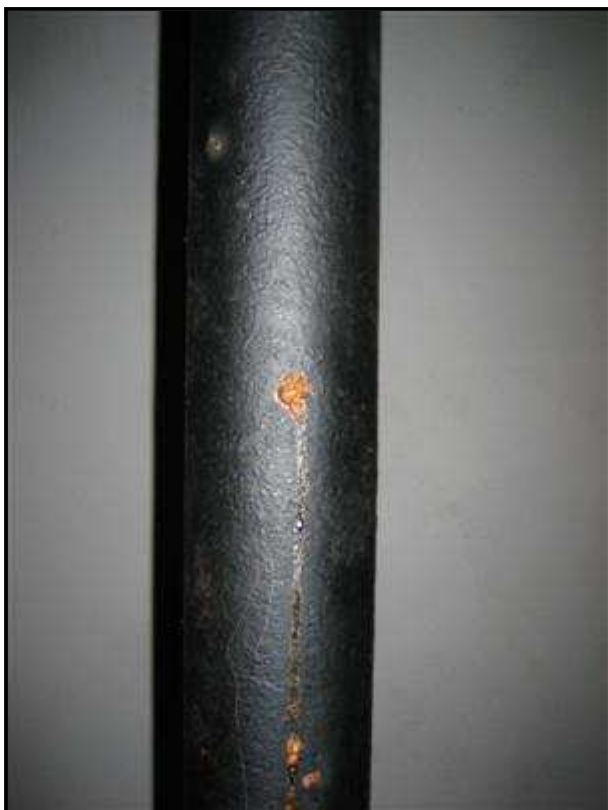
1. Electrical service entrance cable above meter base has sheathing damage and needs replacement; see photo.
2. Laundry area stand pipe has corrosion deterioration and needs replacement; see photo.
3. Both main plumbing waste stacks and closet bends in basement are showing showing corrosion barnacles due to seepage leaks from interior of stacks; replace as needed. Since stacks have been painted, assume pitting is worse than currently evident and that plumber will recommend a considerable amount of replacement. It should also be noted that there would be considerable more seepage evident if bathrooms were being used

- on a daily basis. See photos for examples of seepage barnacles.
4. Rear foundation wall has the potential for inward movement if back yard regarding and improved drainage away from foundation are not performed as recommended. Middle of wall has already leaned inward at least one inch; see photos.

3.0 Picture 4 Main Stack Seepage Barnacles

3.0 Picture 5 Main Stack Seepage Barnacles

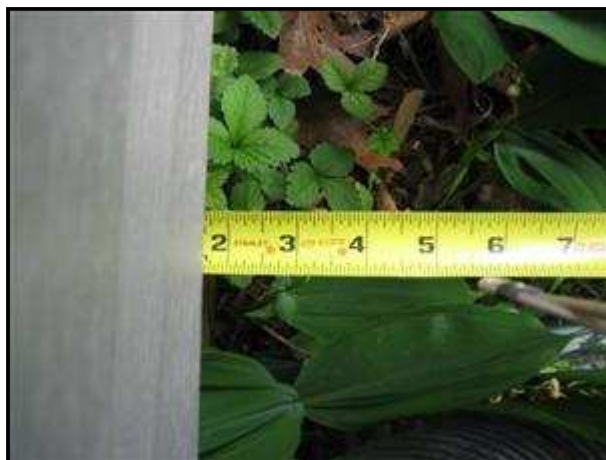
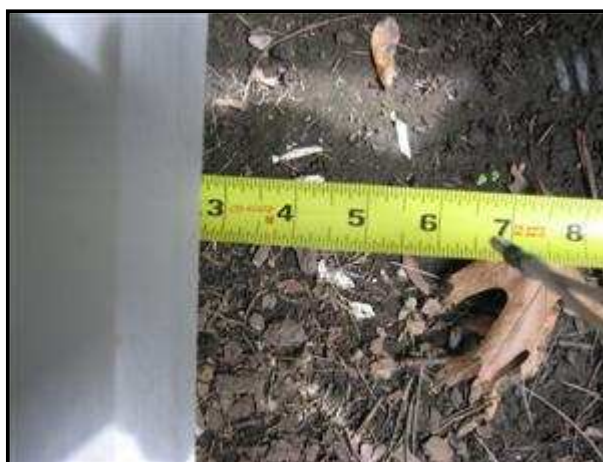
3.0 Picture 6 Tape measures 1 3/4 inch to foundation wall at bottom of siding near SW corner rear wall.

3.0 Picture 7 Tape measures 2 3/4 inch to foundation wall at left center of rear wall bottom of siding.

The foundation walls are poured in place concrete construction; full basement design. The visible portions of foundation walls and adjacent structures appear to be performing as intended, however, rear wall has moved inward laterally due to poor yard drainage. There are no wall cracks of any significance nor any indications of reportable differential movement. Conversely, rear yard needs to be regraded and possibly some drainage piping might be needed to create positive drainage away from rear wall, otherwise wall stabilization procedures will be required if continued movement would be noted in the future.

Regrading of yard is required, especially backyard and all areas adjacent foundation to create positive drainage away from foundation.
