Inspection Report

Property Address:
123 Hollywood Lane
Kirkwood MO 63122

Date: 7/17/2010	Time: 10:00 AM	Report ID: 14413
Property: 123 Hollywood Lane Kirkwood MO 63122	Customer: John Q. Public	Real Estate Professional:

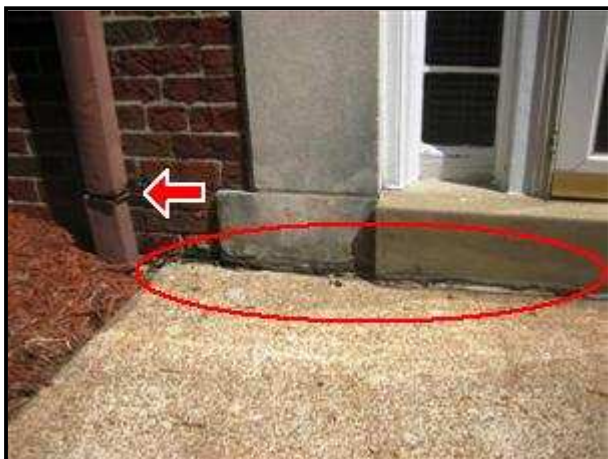
2.0 Picture 1

1. Photo 1: Re-connect downspout joint (left arrow) and re-seal porch slab joint adjacent front of house.
2. Front storm door frame needs adjustment or weatherstripping to eliminate gap at top of storm door.
3. Photo 2: Install cover plate at open electrical junction in attic (right arrow).
4. Replace dirty return air filters at both furnaces.
5. Sand and paint front door wood trim areas that are showing age and weathering.

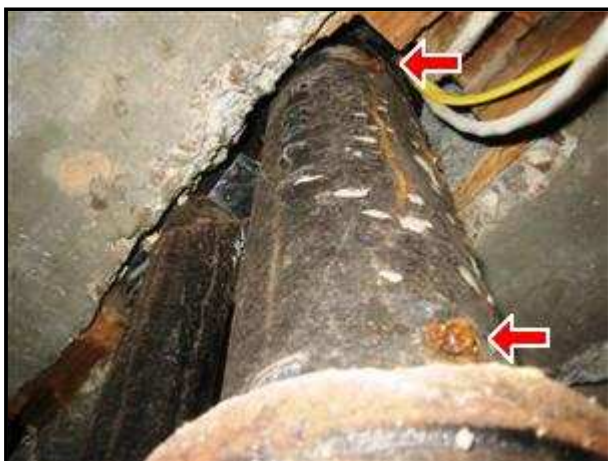
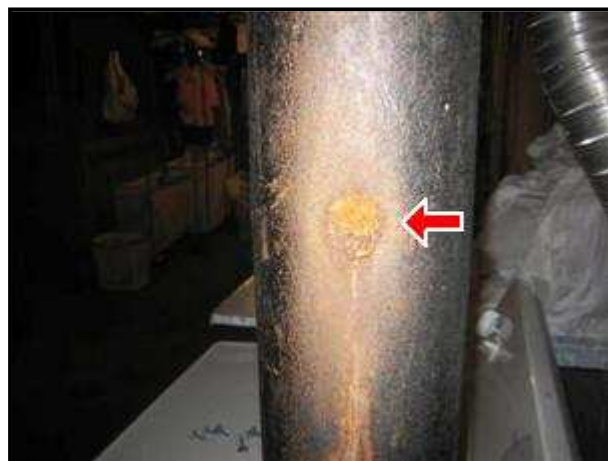
1. Photos 1-2: Main waste pipe in basement and running up into floor has barnacles that are seeping. Contact a licensed plumber to replace waste pipe as needed.
2. Photos 3-7: Steel lintels above front corner windows have corrosion expansion (down arrows) which are causing cracks in masonry walls. Steel lintels need to be wire brushed and painted to stop corrosion which should include removal of upper window frame trim (see photo 6- note and line pointing to trim) to determine condition of the portion of lintels that have been covered by trim. Additionally, after lintels behind trim are inspected and painted, top edge metal trim should be caulked to prevent moisture penetration behind trim. Have lintels cleaned/painted and wall cracks tuckpointed/repared by a masonry contractor.
3. Photo 8: Gutter boards are showing isolated moisture damage and are due for sanding a painting.

The waste piping is mostly the original cast iron and the main floor drain is located in the basement utility area. Main waste pipe is leaking (see "Repair Notes").

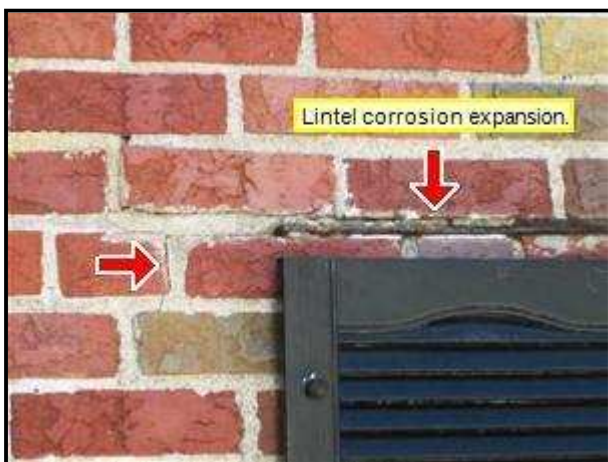
3.0 Picture 3 - West wall of house.

FYI: The key to exterior maintenance is prevention of moisture penetration, best accomplished by spot tuck-pointing, painting, caulking, and roofing repair on a timely basis when needed; do not delay maintenance or repair issues when such conditions are observed. Caulking the dissimilar materials around the exterior doors, windows and all wall penetrations/joints is recommended in keeping with good building practice. Note: Tuckpointing at brick walls is not needed until mortar joints become over a half inch deep and mortar is loose. Also tuckpoint any cracks in joints that become more than hairline in width. Steel lintels above corner windows are corroding and need immediate attention and appropriate repairs.

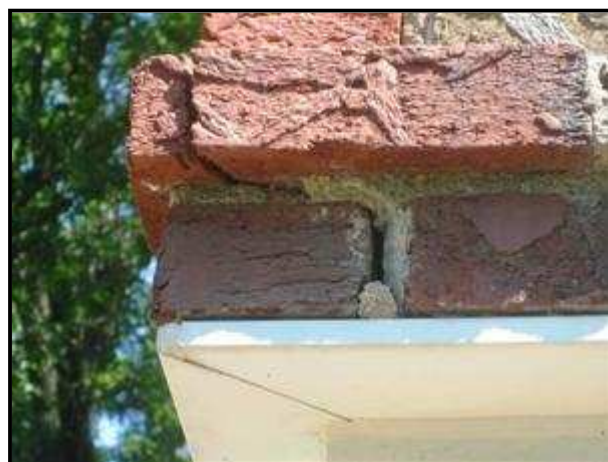
3.0 Picture 4 - SW corner of house.

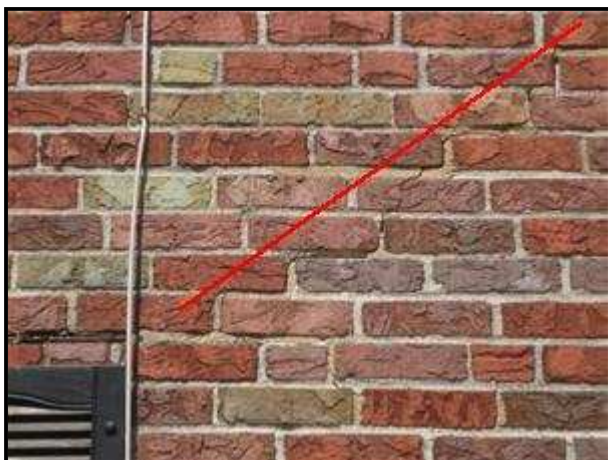
3.0 Picture 5 - Wall crack in east wall from lintel corrosion expansion.

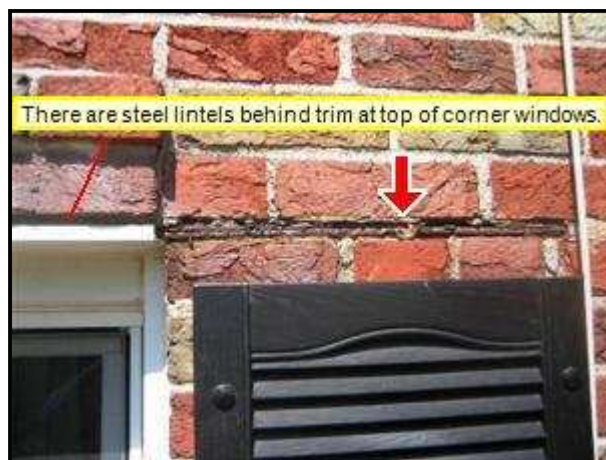
3.0 Picture 6 - East wall of house.

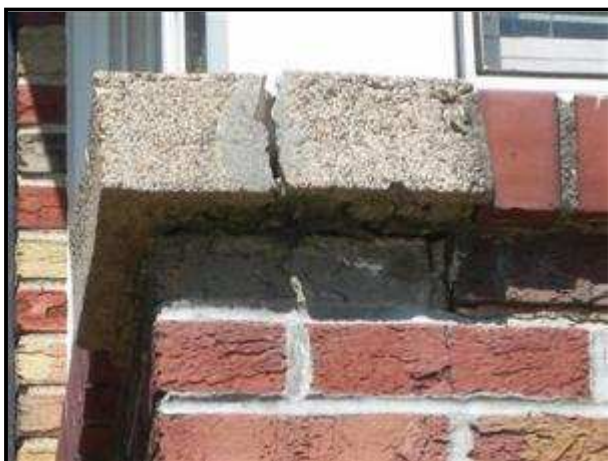
3.0 Picture 7 - SE corner of house.

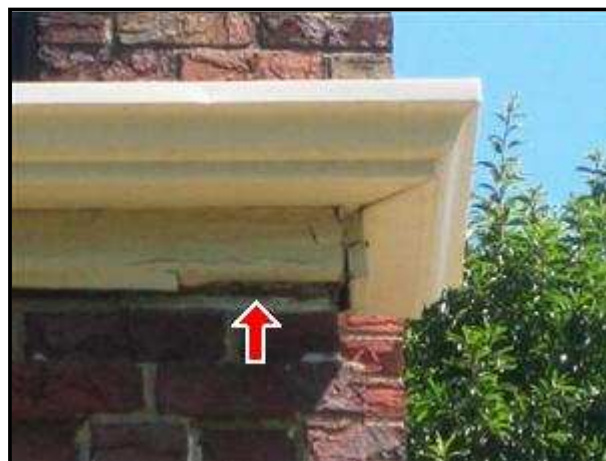
3.0 Picture 8 - SE corner.
